SOUTH GATEWAY TIF

Long Grove, Illinois

Joint Review Board Meeting

Friday, October 9, 2020

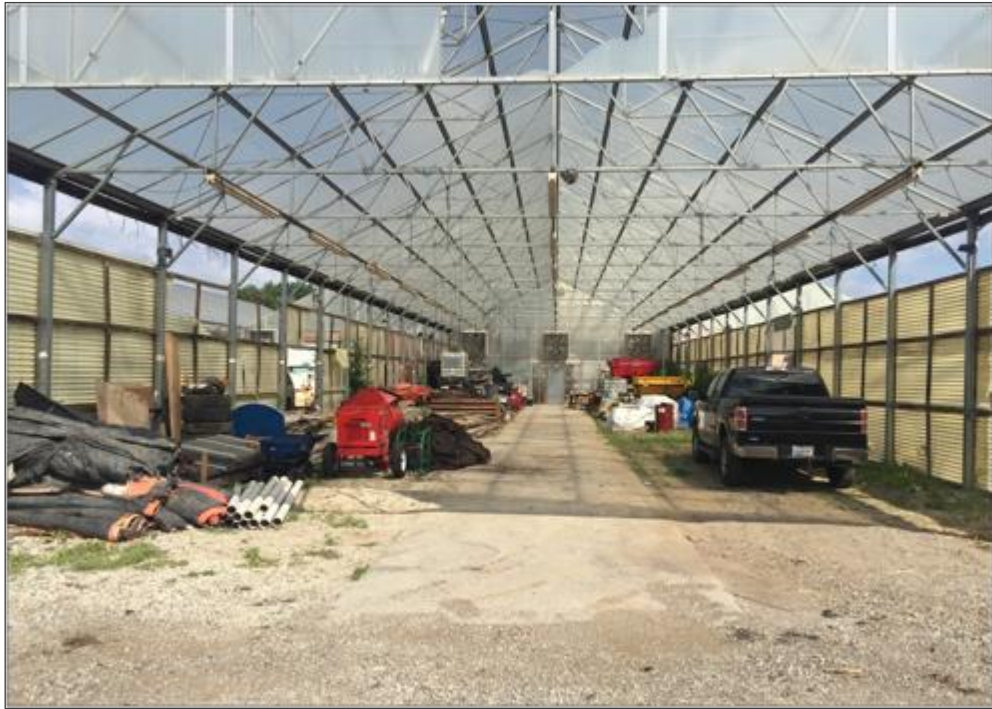
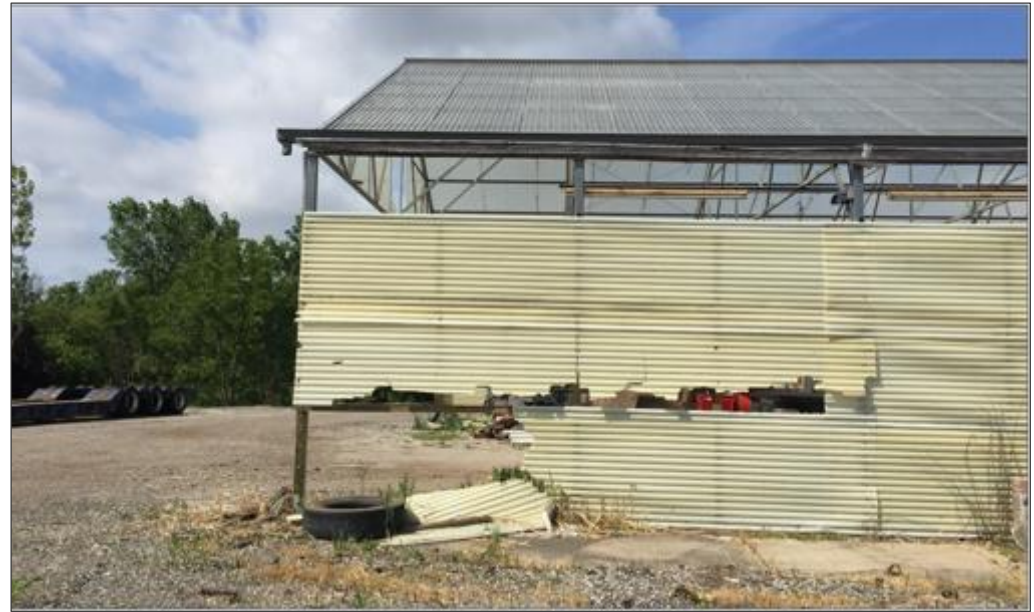
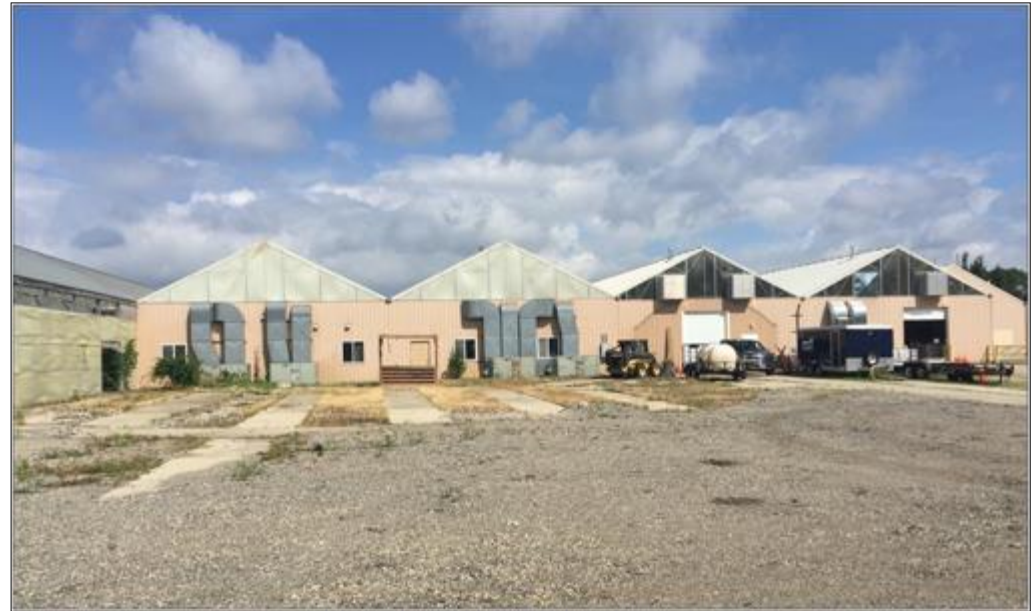
OBSOLESCENCE

- Obsolescence, both economic and functional, is present for two properties occurring on multiple attached buildings in a single building complex (extends over two parcels).

In general, **functional obsolescence** relates to the physical utility of a property or structure, and **economic obsolescence** relates to the ability of a property or building to compete in the marketplace.

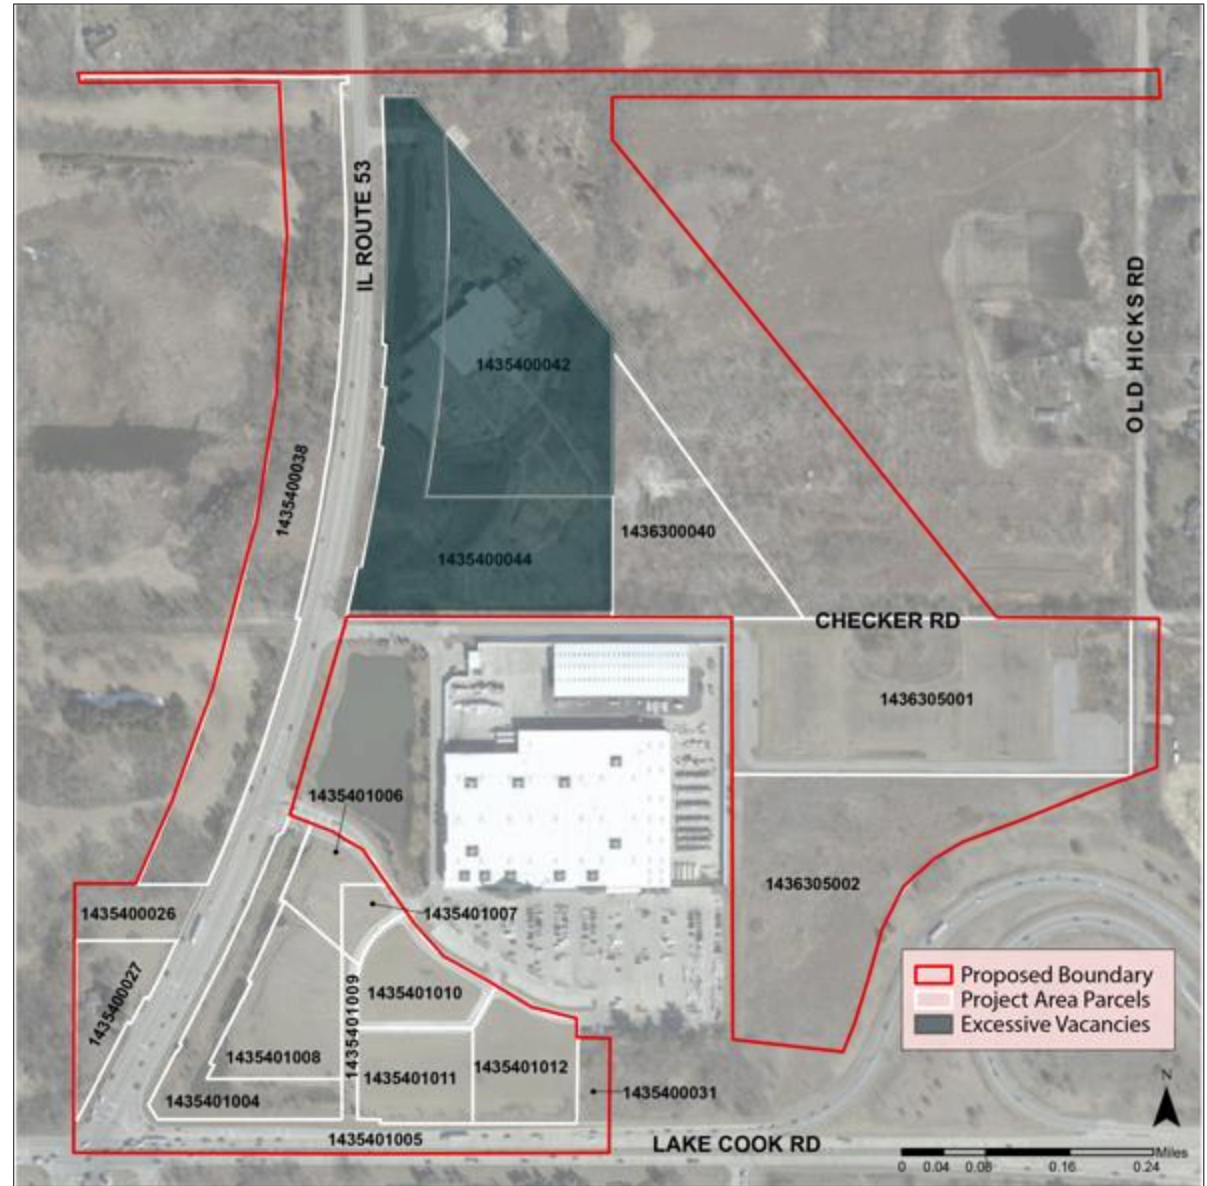
- The complex at 2727 Old Route 53 displays an extreme physical state of disrepair, with neither tenants using or maintaining the greenhouse.
- Evidence of wall, floor, and structural dilapidation is also present.

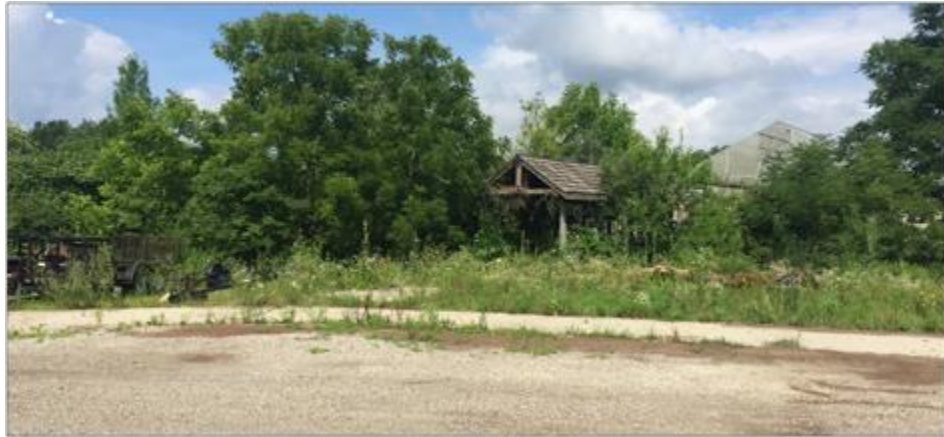
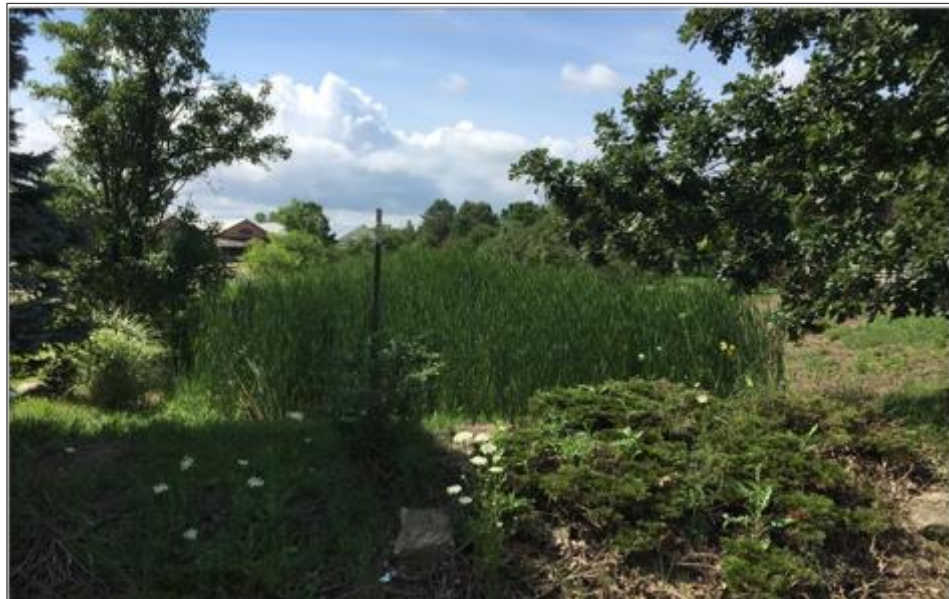
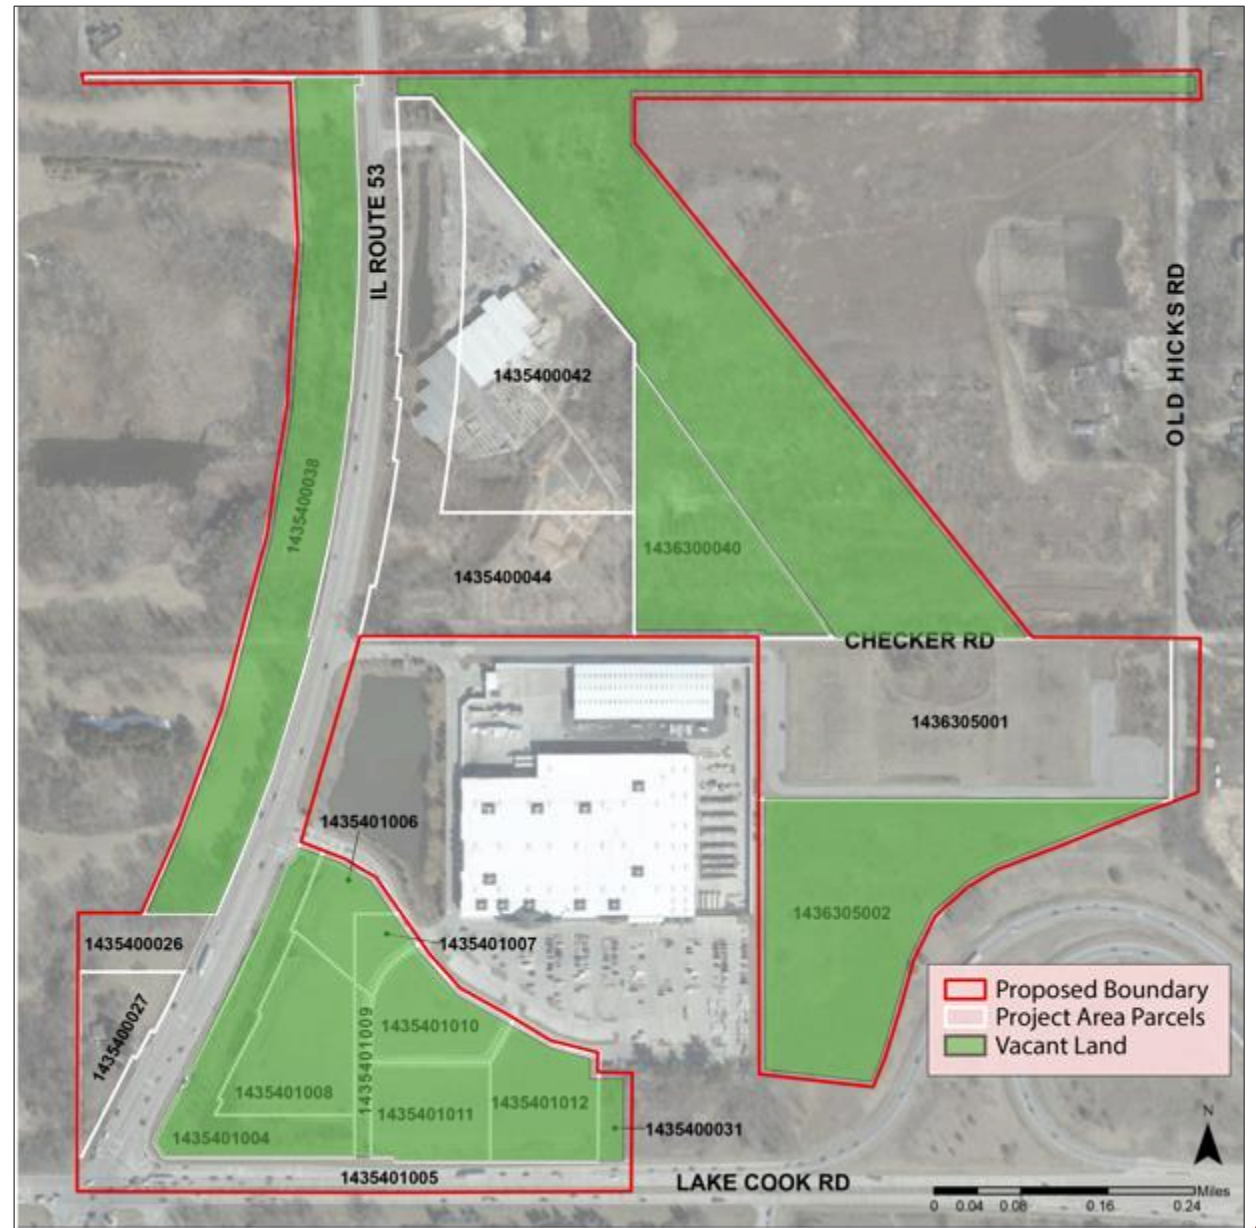
EXCESSIVE VACANCY

- One (1) of two (2) buildings in the Project Area is vacant.
- A significant portion of the Project Area includes subdivided land that has remained vacant and undeveloped
- Vacancies of these parcels have adversely influenced development opportunities within the Project Area.

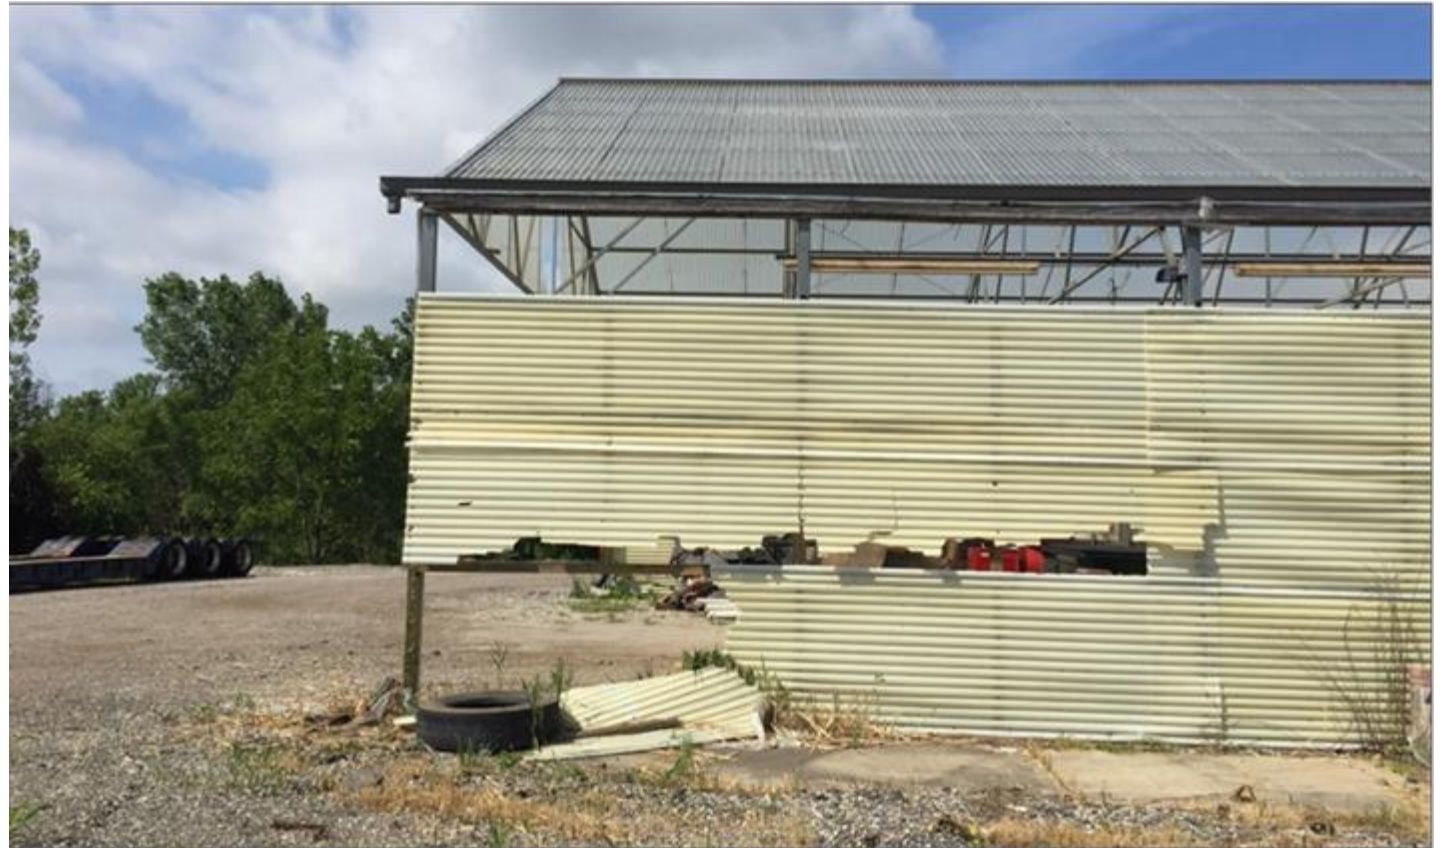
- 2 out of 2 buildings exhibit deteriorating characteristics.
- Clear evidence of building and site deterioration can be seen from rights-of-way or adjoining properties, which includes:
 - siding becoming undone, potentially exhibiting cracks in masonry walls and foundations
 - overall aging of windows and doors
