PHILIP ESTATES SUBDIVISION

Long Grove, IL

PRELIMINARY STORMWATER MANAGEMENT SUMMARY

Dated Prepared: March 2020

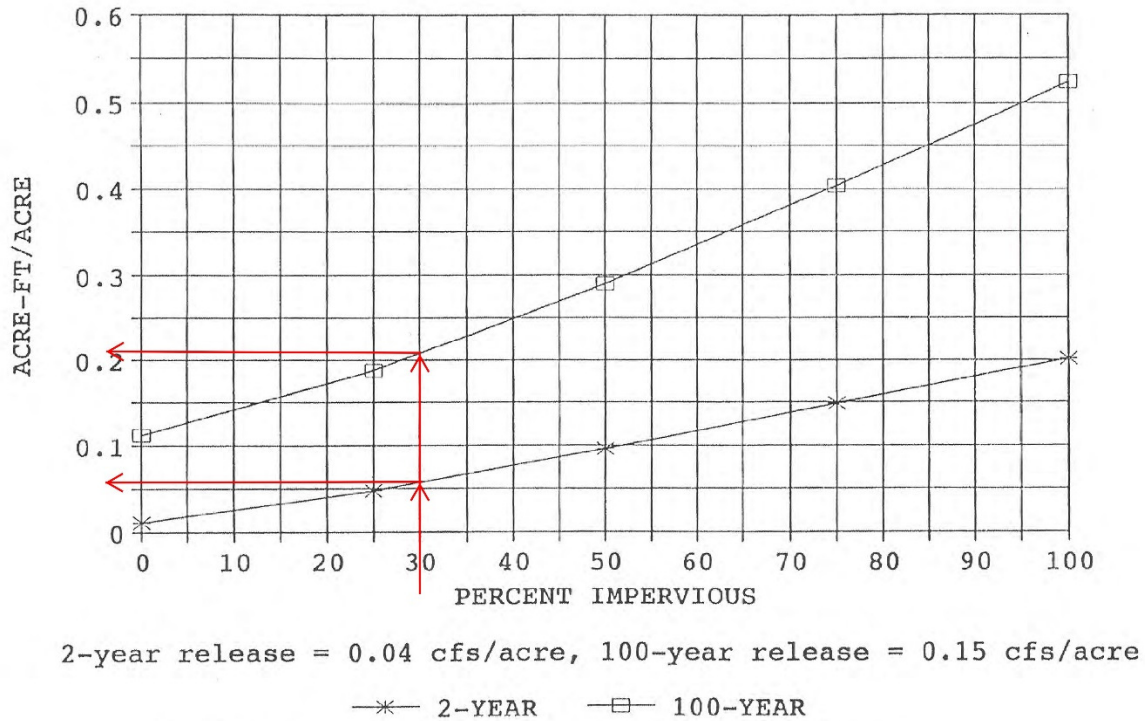
Figure 1

DETENTION VOLUME VS PERCENT IMPERVIOUS 2-YEAR AND 100-YEAR UNIT AREA DETENTION

Reference: Northeastern Illinois Planning Commission, Investigation of Hydrologic Methods
for Urban Development in Northeastern Illinois

The complete existing conditions model (1 – 170918_CP6FF.INP/RPT) establishes the on-site HWL of 736.2 with an existing discharge of 10.3 cfs to the Buffalo Creek headwaters pond. The off-site only existing conditions model (2 – 170918_CP6FF_NO.INP/RPT) establishes the use of approximately 5.2 acre-feet of storage in the on-site western low area with a corresponding 100-year off-site only discharge of 3.5 cfs. The proposed model (3 – 200303_CP6FF_DEV.INP/RPT) shows a reduced HWL for the western on-site low area (proposed HWL of 735.4) with a proposed discharge of 7.5 cfs to the Buffalo Creek headwaters pond. The proposed 100-year allowable discharge is computed as 0.15 cfs/ac times the on-site area of 35 acres for an on-site allowable discharge of 5.3 cfs. This is added to the off-site only 100-year discharge of 3.5 cfs for a total allowable discharge of 8.8 cfs (which is more than the computed proposed condition discharge to the southeast). The required proposed storage volume consists of adding the off-site only storage of 5.2 acre-feet to the Ordinance recommended developmental storage volume of 0.21 acre-feet per acre of development times 35.5 acres for an on-site detention volume of 7.5 acre-feet (see following annotated chart) for a total volume requirement of 12.7 acre-feet, which is less than the proposed plan volume of approximately 13.7 acre-feet.

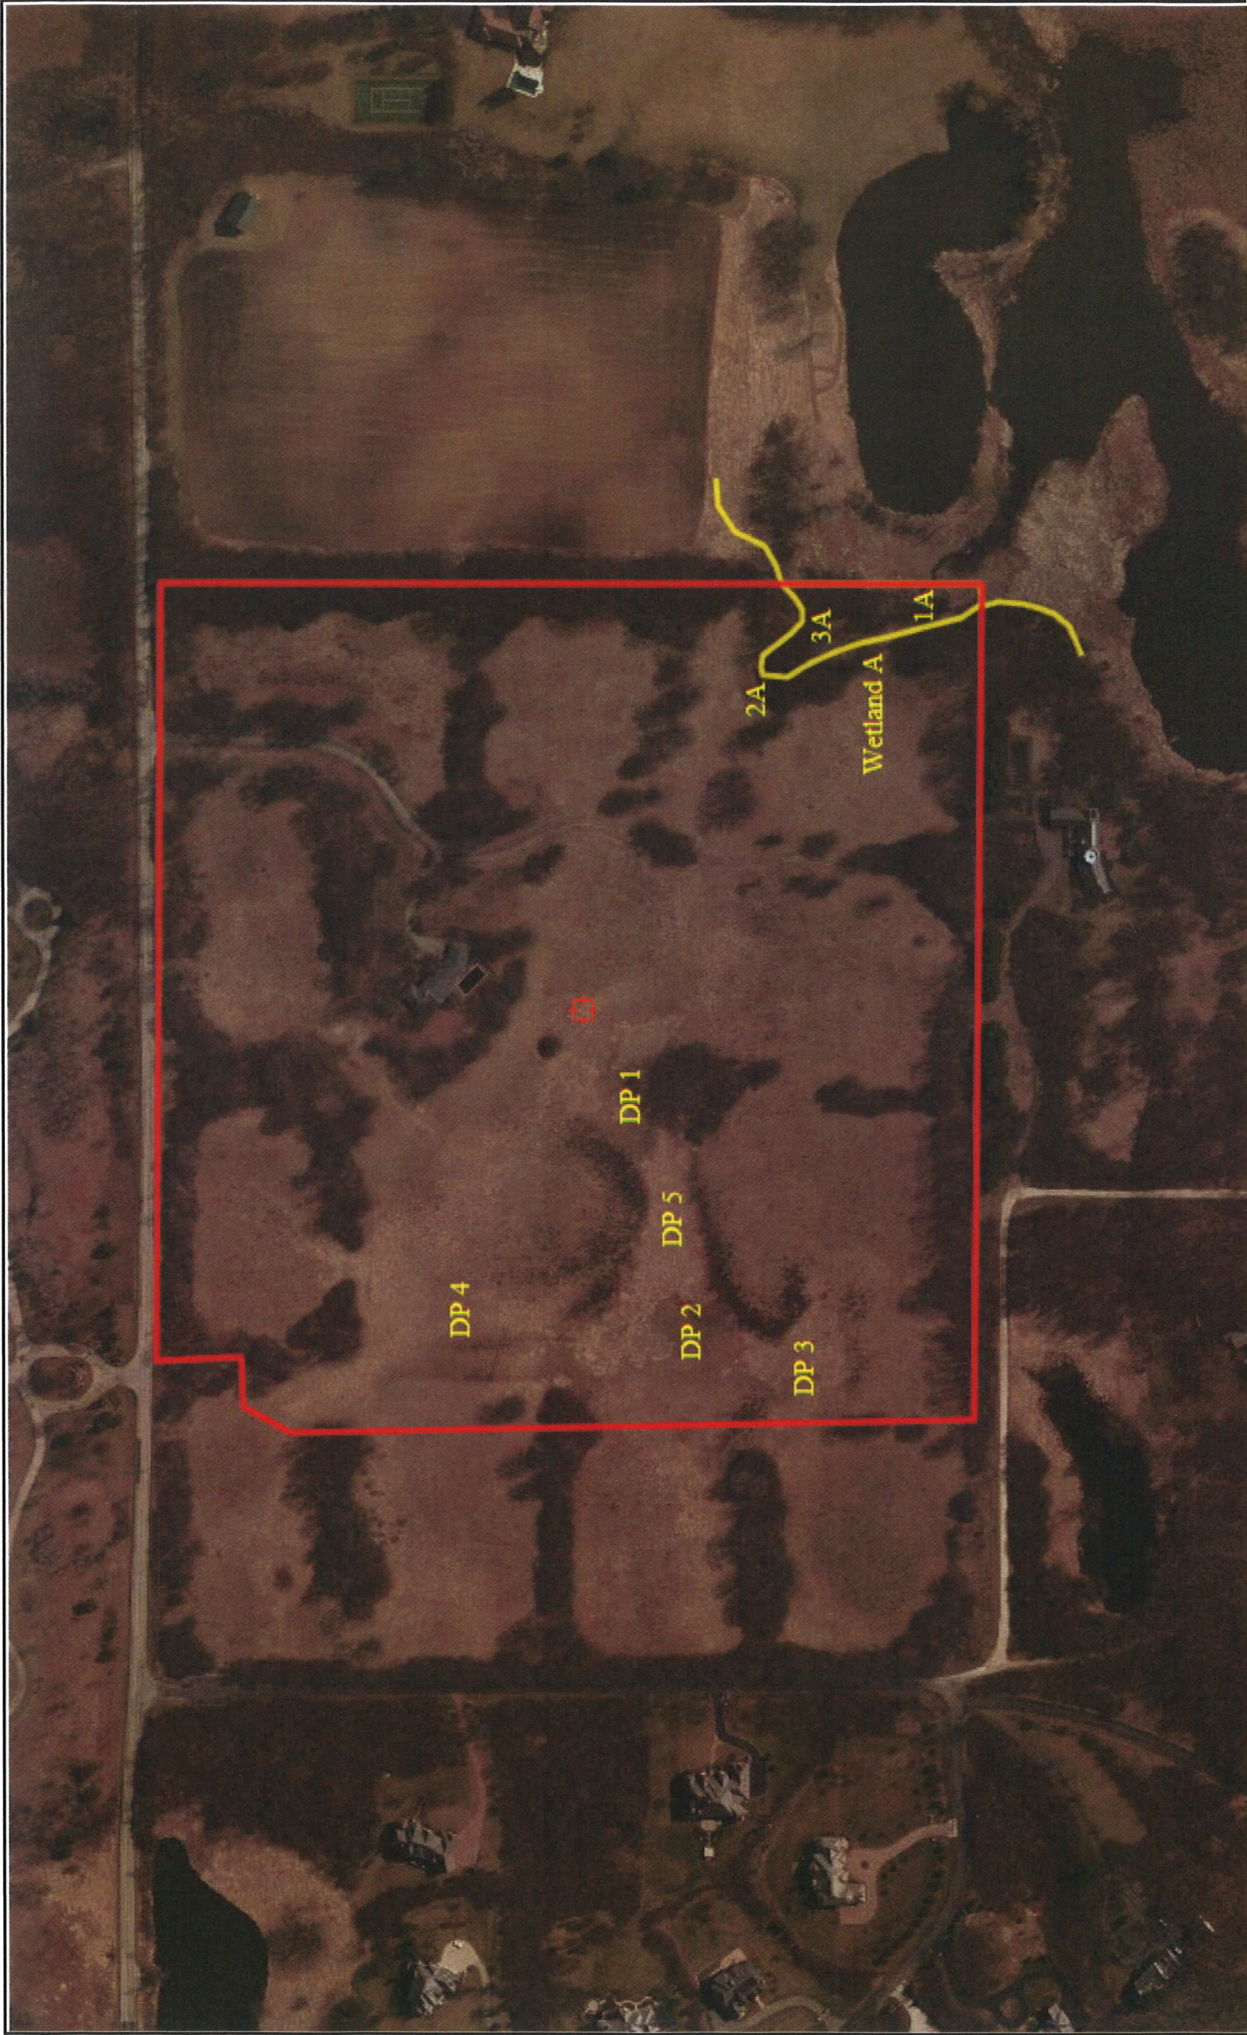
Final Wetland Location Map

Source: Pictometry Aerial Photograph

Wetland A: Wetland A is a scrub shrub/marsh wetland that is found at the southeast corner of the study area. The wetland is part of the larger Buffalo Creek wetland Complex. Wetland A is characterized by data point 1A & 3A and is **0.37 acres** in size. The flagged wetland is a lowland area surrounded by steep slopes that continues to the east. The Lake County Advanced Identification Map shows this area as High Quality Aquatic Resource # 180. The dominant
